Styx Report: 2005/2
AEL32

Trout Spawning in the Styx River

An Update

CHRISTCHURCH
CITY COUNCIL - PARKS & WATERWAYS

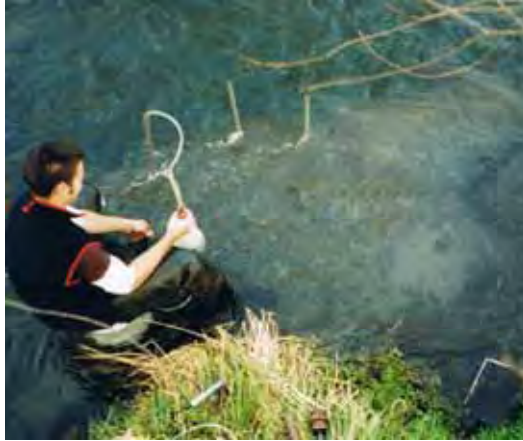
Figure 3a. Pumping water samples from stainless wells driven into a trout redd.

DO was firstly measured from open water at the stream bed surface, and IGDO readings were then obtained from duplicate water samples at a depth of 0.15 m and 0.25 m within each redd. The 0.15 m depth represents a mid-point on measured gravel depths for brown trout egg pockets on the Selwyn River (0.1 m – 0.2 m) (Hardy 1963). The 0.25 m depth would represent a possible value for redds excavated by particularly large fish. Water samples were collected from open-ended, stainless steel wells (15 mm internal diameter), driven into the stream bed using a steel driving rod (Boulton *et al.* 1997). A hand-operated bilge pump was used to extract water from the well, with the first, turbid litre of withdrawn water discarded (Fig. 3a). The IGDO reading was then determined by pumping water in an unbroken stream until a small container overflowed. A YSI dissolved (DO) probe was then inserted and DO recorded in the field once readings had stabilised (Fig. 3b).

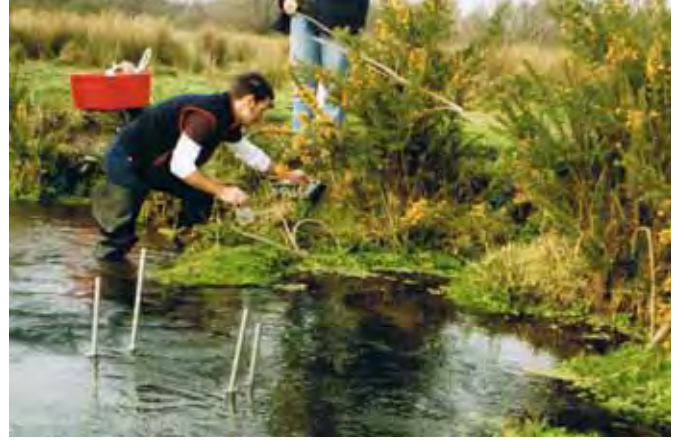
Figure 3b. Field measurement of IGDO. Two readings were recorded from water samples taken from two depths at each of two trout redds. The YSI® DO meter is in the foreground.

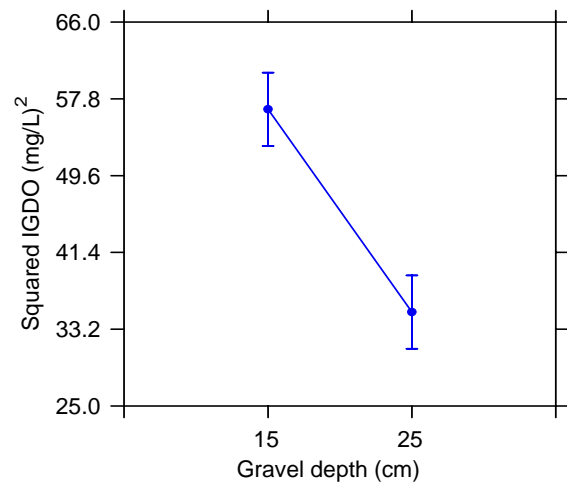
Figure 5b. Least squares means of IGDO by gravel depth.

To facilitate statistical analysis, the IGDO data were squared to overcome significant negative skewness in the untransformed IGDO dataset necessary to satisfy the assumptions of a parametric ANOVA approach (i.e. data subsets categorised by river/location and gravel depth, $n = 6$). Using the transformed data, IGDO varied significantly between redd locations (Fig. 5a, $F = 13.2$, $p < 0.01$), and gravel depth (Fig. 5b, $F = 15.32$, $p < 0.01$).

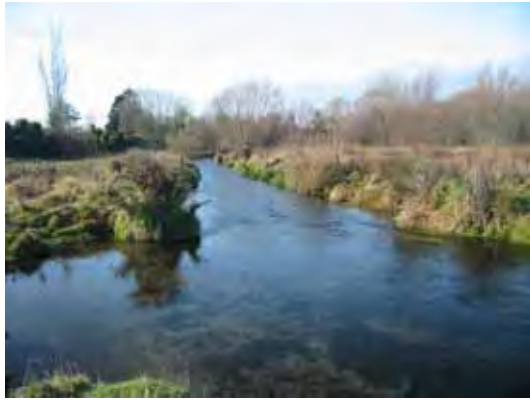
Figure 8. The fenced reaches of the Styx River mainstem.

Three minor tributaries of the Styx River were also surveyed, two boxed drains, and Mill Stream. The two boxed drains feed the excavated ponds in the Styx Mill reserve (Fig. 8). The eastern drain had an entirely silted substrate, sluggish flow, and was of no value for trout spawning. In contrast, the western boxed drain had a gravel substrate, with a moderately fast flow. Several trout redds were present within the boxed section immediately downstream of the Styx Mill Road culvert. The 90 m boxed section had a width of 1.5 m, and a depth of approximately 0.2 m and a predominantly coarse gravel substrate. Downstream of the boxed section, the banks were grassed, and channel was approximately 2 to 3 m in width, with a mid-channel depth ranging between 0.2 and 0.3 m. This section was silted, slow-flowing, and discharged into the main excavated pond in the Styx Mill Conservation Reserve. The ponds were linked to each other, by gravel-substrate rapids, before the flow discharged into the Styx River mainstem. A shallow concrete ford in the lower reach may present a problem for trout access, and this impediment is discussed in Section 5.6.

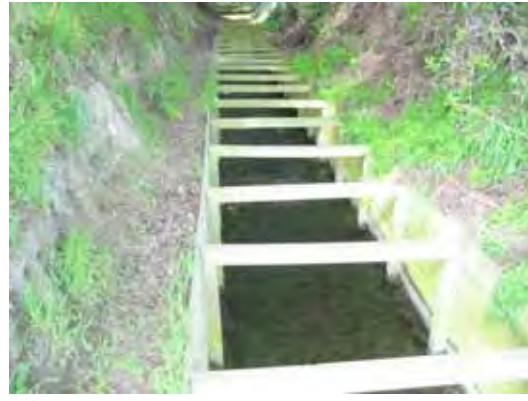
Figure 9. The boxed drain which feeds the excavated ponds in the Styx Mill Conservation Reserve. The drain gravels were used for trout redd excavation.

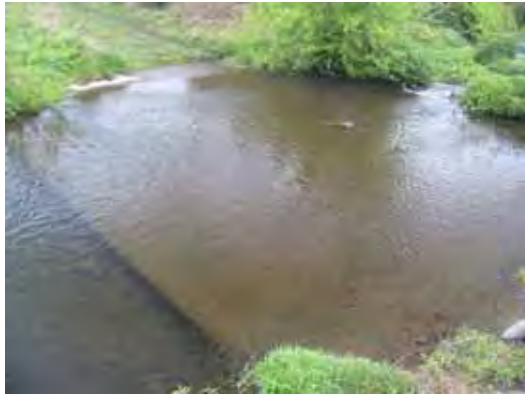
Figure 11. Concrete ford across lake outlet. Water depth was c.a. 7 cm.

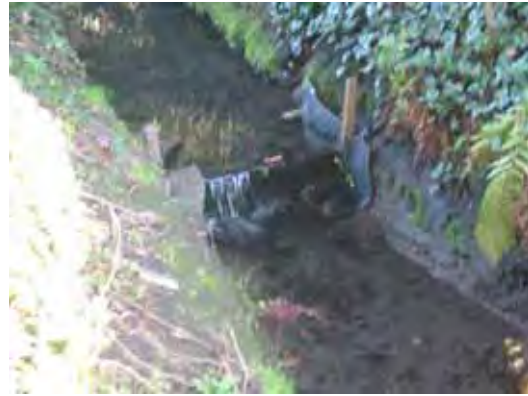
Figure 12. One of two small weirs in the upper reaches of the Styx River mainstem.

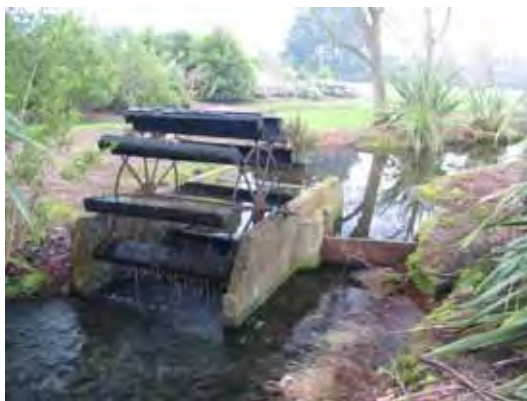
Figure 13. The ornamental mill wheel and weir on the upper reaches of Smacks Creek.

At the downstream end of the reserve, an ornamental waterwheel impounds the flow. Downstream of this structure, the tree-shaded channel was approximately 2.5 m wide, with a silt-embedded cobble and gravel substrate. The flow was a moderate run, but shallow (depth 0.15 m). Two trout parr were observed in a short channelised section through a horse paddock opposite the Husseys Road intersection. Downstream of this section, the level of embeddedness decreased, and the substrate became a mixture of large and fine gravel, with a water depth of 0.15 m depth. The flow was a moderate run, and several trout redds were found in the vicinity. A local resident and angler (Mr O'Neill, pers. comm.) expressed concern that silt, periodically dislodged from behind the waterwheel by maintenance crews, caused large sediment plumes downstream.

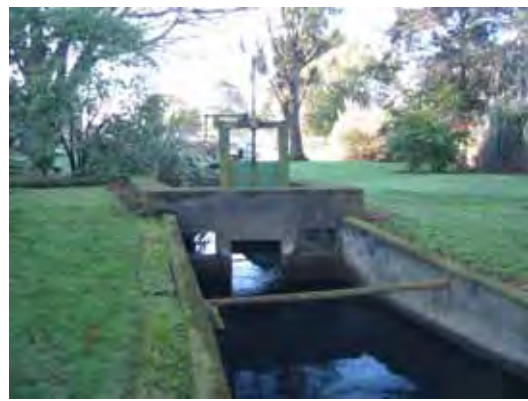
Figure 14. Sluice gate on the middle reaches of the Kaputone Stream.

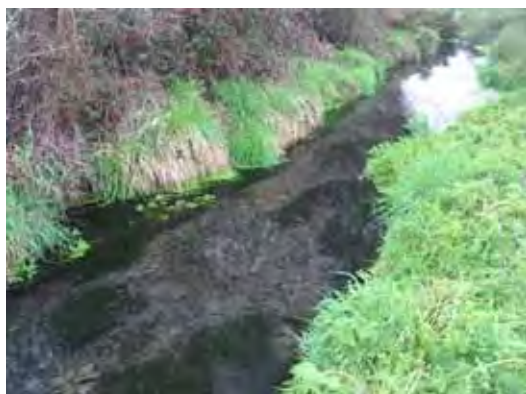
Figure 16. Bark chips in the Smacks Creek Esplanade Reserve downstream of the firewood store. Photo taken on 8 August, 2005

Despite recommendations by Taylor and McMurtrie (2003) for their removal, there is still a significant quantity of bark chips Smacks Creek downstream of Gardiners Road. The source of the material is from the firewood yard immediately upstream of Gardiners Road (Fig. 16). The winter foot survey revealed there was an ongoing threat of further sawdust entering the channel and smothering the gravels (Fig. 17).

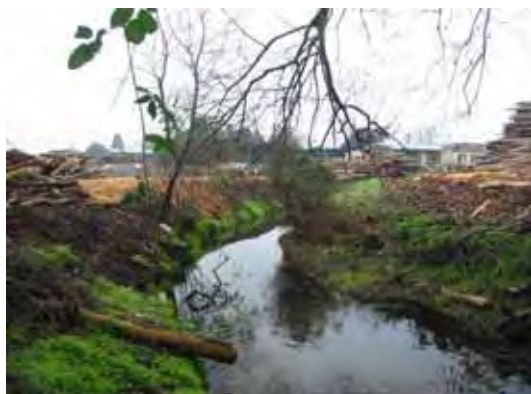
Figure 17. Sawdust (centre left) and logs perched on the bank of Smacks Creek upstream of trout spawning gravels. Photo taken on 8 August, 2005.
