February 2002

Styx Report: 2002/1
AEL7

**The Waterway along Regents Park Drive;
A Consideration of its Ecology and Habitat Access**

CHRISTCHURCH
CITY COUNCIL · PARKS & WATERWAYS

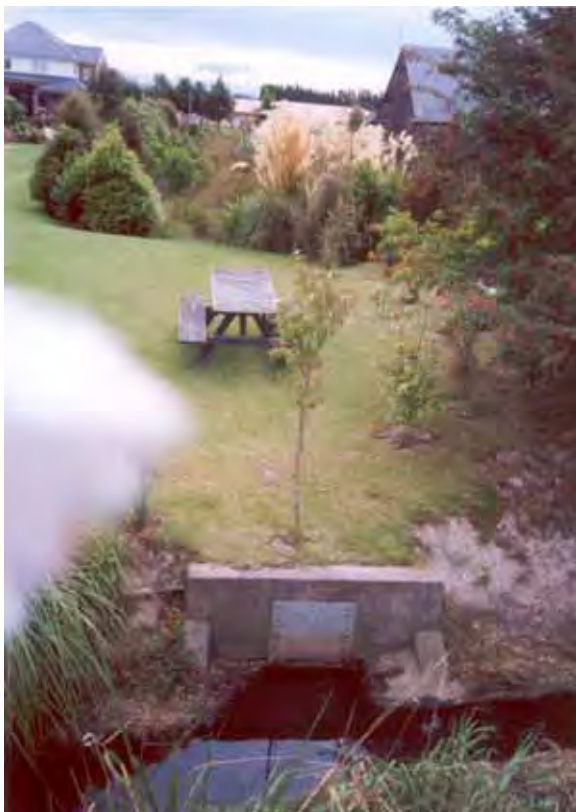
Figure 2. The concrete intake which diverts flow through a pipe (under the garden seat) into the vegetated channel in the background.

It is clear that the a degree of substrate siltation occurs, and that the waterway profile along Regents Park Drive is too large in respect to the flow available. Being almost entirely spring-fed, the system lacks flushing flows to remove sediment. The intake structure (Fig. 2) appears to diverting only a small proportion of the flow of the railway drain, and it may be possible to augment the diverted flow by modifying or unclogging this structure. Conceivably, over time, the channel could be effectively narrowed by emergent vegetation like the native rush *Juncus pallidus* or the planting of raupo.

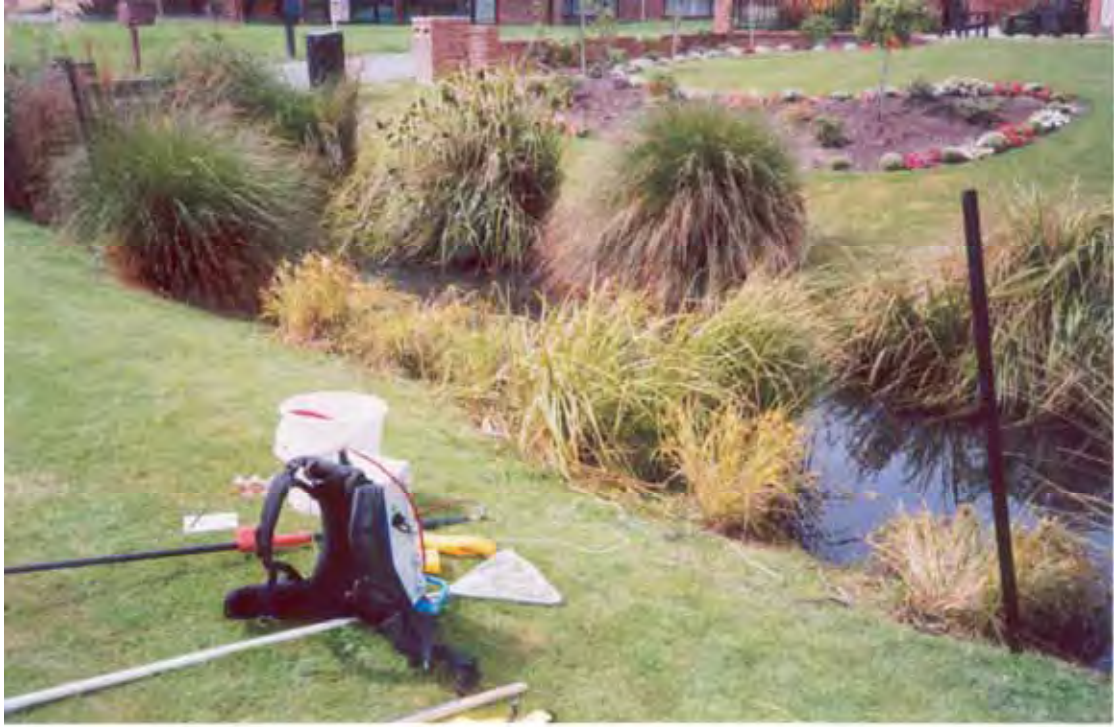
Figure 3. Site 2 , a random 7m section of the diverted channel which flows parallel to Regents Park Drive. The Waratahs indicate the section boundaries, and the electric fishing machine is in the foreground.

Two short (7m) representative study sections were selected (by random number generator) from the watercourse alongside Regents Park Drive. Three combined invertebrate kick-net (420 micron mesh) samples were obtained from the substrate; equidistantly across the stream profile, and just downstream of these sections. The invertebrate fauna was identified by naked-eye inspection and a low-power magnifying glass.

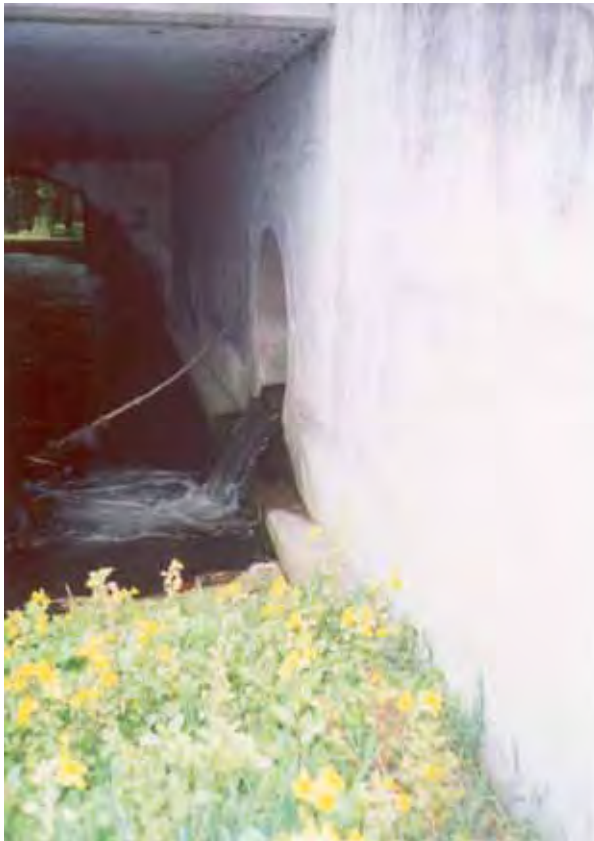
Despite a reasonable amount of fishing effort in habitat suitable for juvenile eels, the relatively high numbers of larger and older eels, and the paucity of elvers, indicates possible eel recruitment problems into the culvert. The larger eels are likely to have entered the tributary before the culvert outlet was installed. This suggests that even shortfin eels, which are capable climbers, are having difficulties in colonising the Regents Park waterway. This is likely to be caused by mainly the length and laminar nature of the water flow through the culvert. Many of the shortfin eels captured were at or above the size where they would migrate to the sea to sea. Male eels migrate

Figure 4. Outfall of the Regents Park culvert into the Styx River. Note the damp spray zone which may allow partial upstream access for eels into the culvert.

unsuitably steep to doubly serve as a load-bearing slope for the 4-lane bridge. The free-fall of water at the end of the culvert (c.a. 0.7m) is likely to be maintained owing to the cost of realigning the culvert

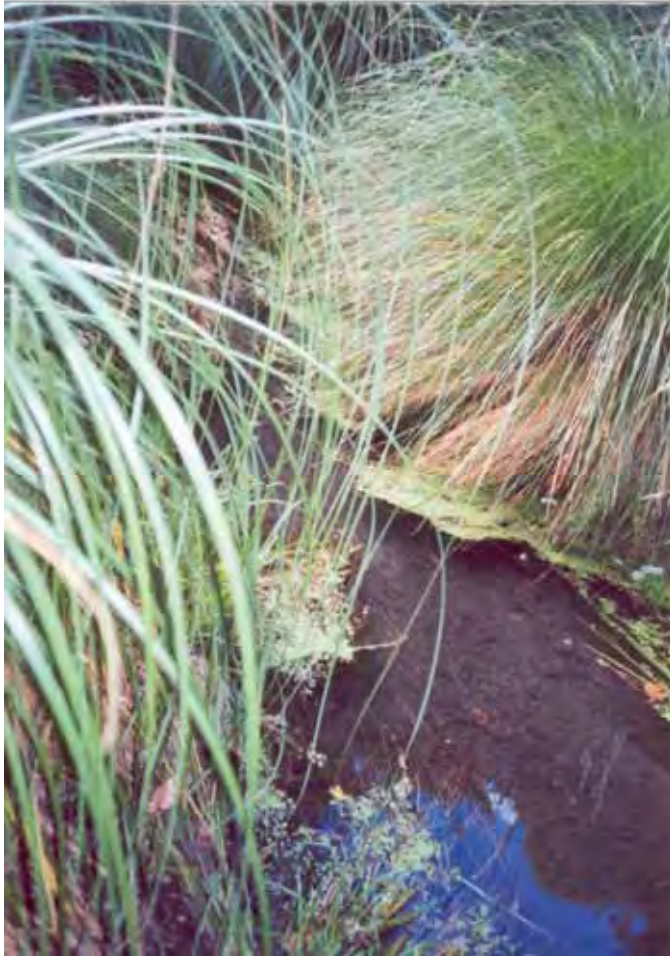
The diversion watercourses both to and from the railway drain were much narrower in width (c.a. 0.8m), with correspondingly faster flows, and cleaner cobble substrate (Fig. 5).

Figure 5. Heavily vegetated waterway on the pond outlet. Upland bullies were abundant here. Note the extent of luxuriant over-hanging vegetation.

Given that upland bullies spawn prolifically here, and trout (and presumably eels) can access other waterways in the Regents Park subdivision, there is an argument for maintaining this habitat as a relatively predator-free environment for native fish, particularly so, as the native fish are growing to a large size. This habitat may also have ecological potential as a reservoir habitat for threatened small native fish species, especially the Canterbury mudfish. These 2 species co-habit in many areas of their natural range, and mudfish could well have occurred naturally in the Styx catchment in the past. It is also recommended that the general ecology and channel morphology in the pond outlet be examined more closely to determine aspects of its ecology which have made this reach so eminently suitable for native fish.

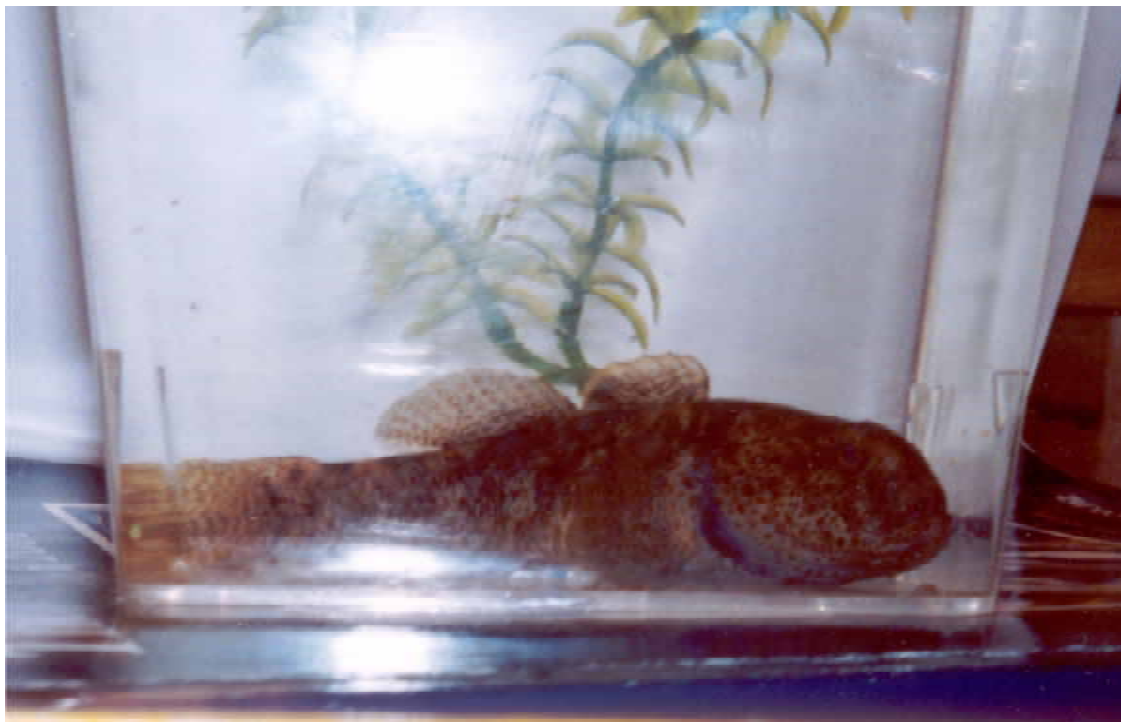
channel had a much higher density (approx. threefold) than the wider channel flowing alongside the road (Table 1). The bullies from the pond outlet also had a much greater size range, ranging from approximately 20 mm in length to a very large adult male which was measured at a remarkable 112 mm in length (Fig. 6). There were a number of other very large bullies present. Many bullies were exhibiting spawning colours, with some gravid females identified.

Figure 6. A 112mm male upland bully obtained from the outlet of the pond on Regents Park Drive. Upland bullies of this size are very rare.

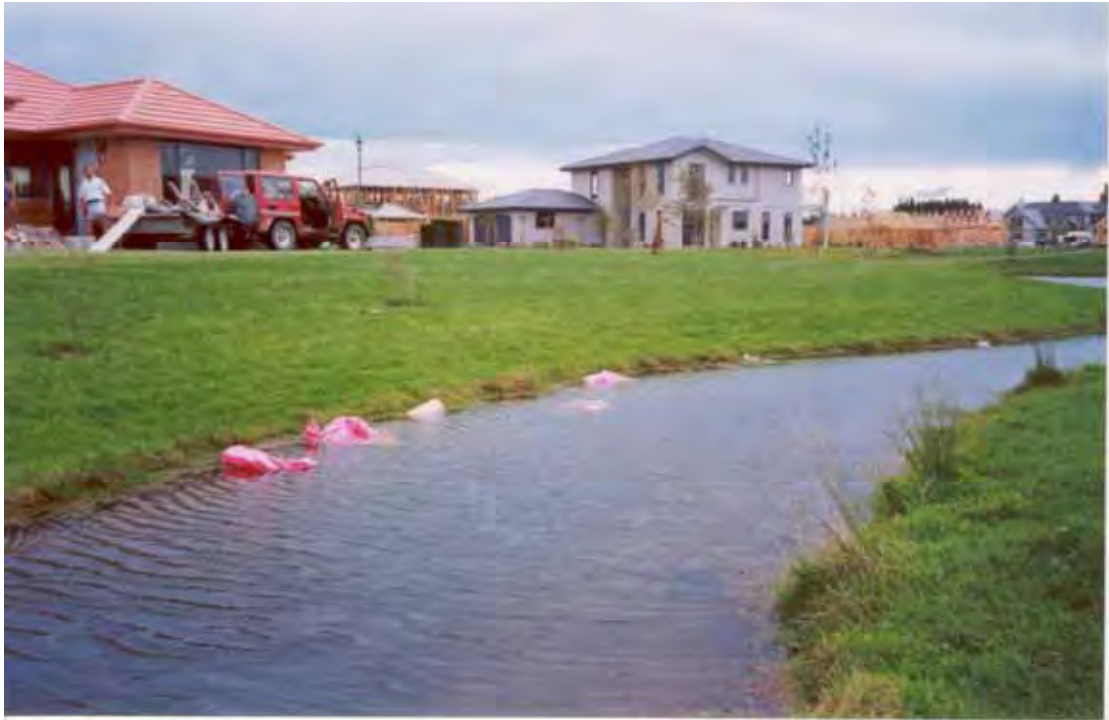
Some care needs to be taken by building contractors to prevent materials from being blown into the waterway from adjacent building sites. A significant amount of fibreglass insulation material was found in the upper reaches, potentially injurious if ingested by birds (Fig. 7). However, upon request, it was pleasing to see contractors remove this material from the waterway. Some local residents also (reportedly) dump grass clippings into the waterway, which may explain the significant amount of fine organic material observed. Clearly this could lead to further nutrient enrichment of the aquatic habitat, and excessive aquatic weed growth.

Figure 7. Pink fibreglass insulation material (and its wrapping) has blown into the waterway from adjacent building sites. Upon request, this rubbish was removed by contractors.

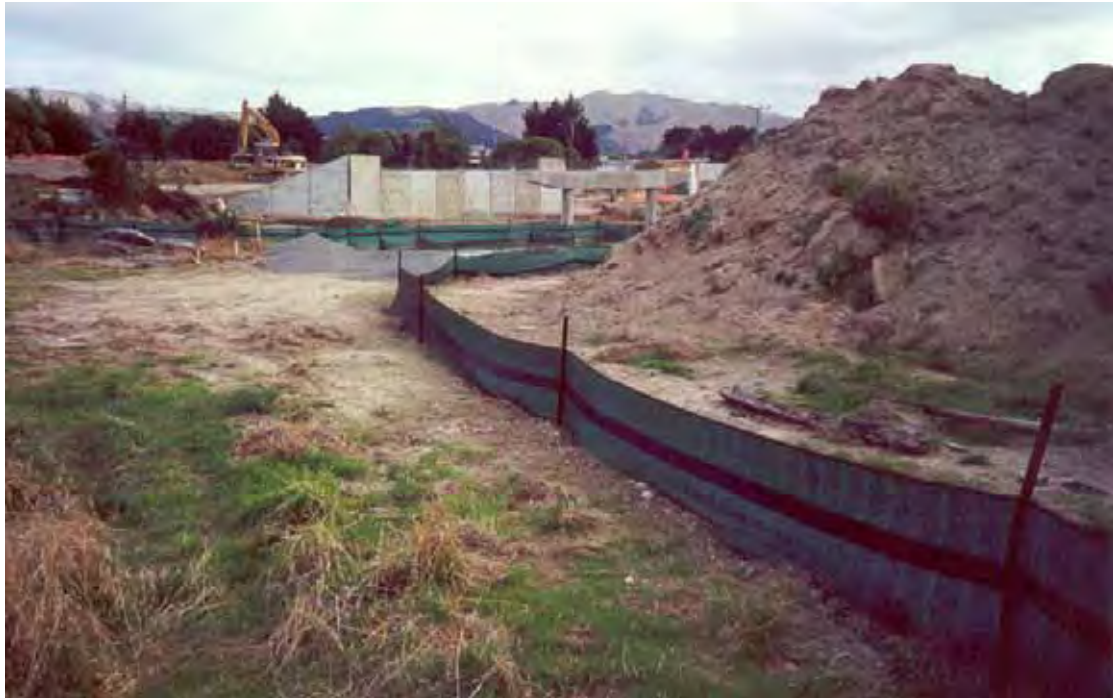
Screening of soil piles to prevent silt runoff during rain events.

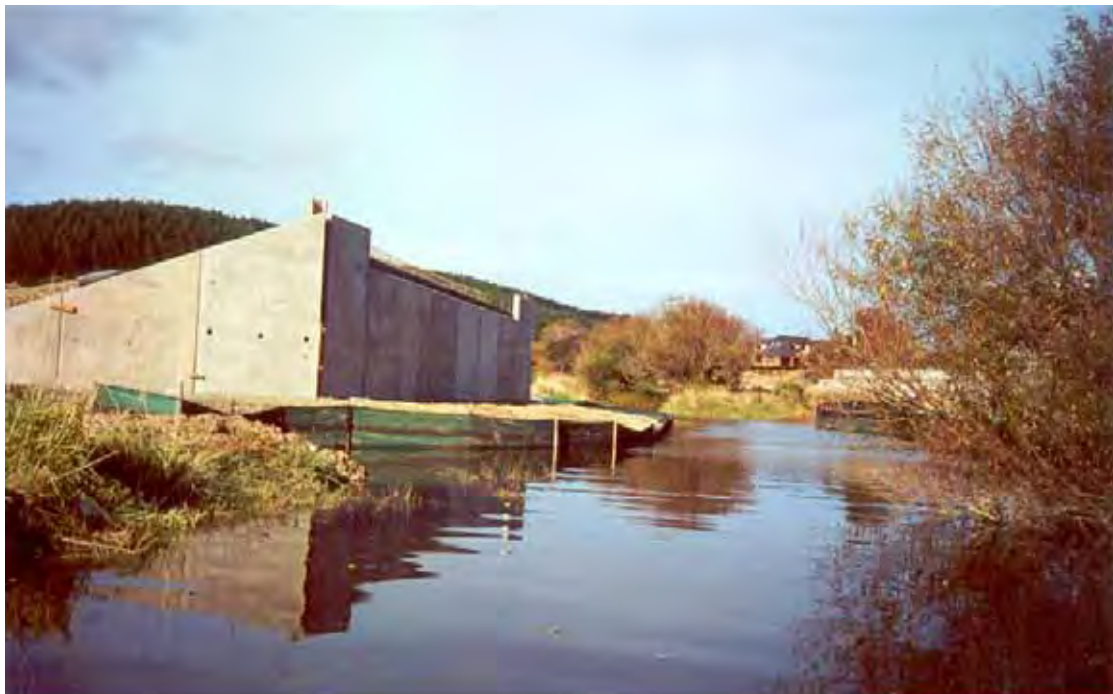
Screening of bridge ramparts to prevent spoil entering the river.

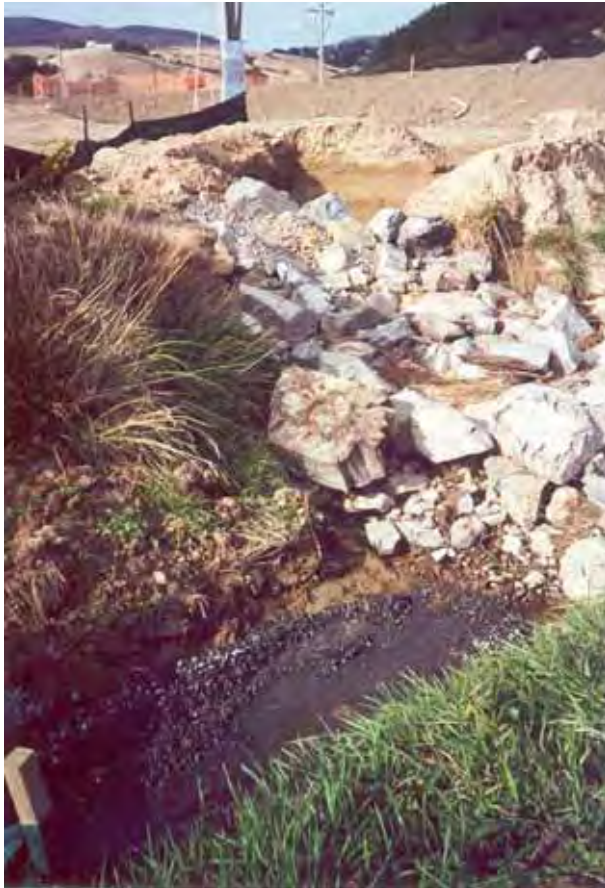
Gravel and screen filter trap to reduce silt from pump water.

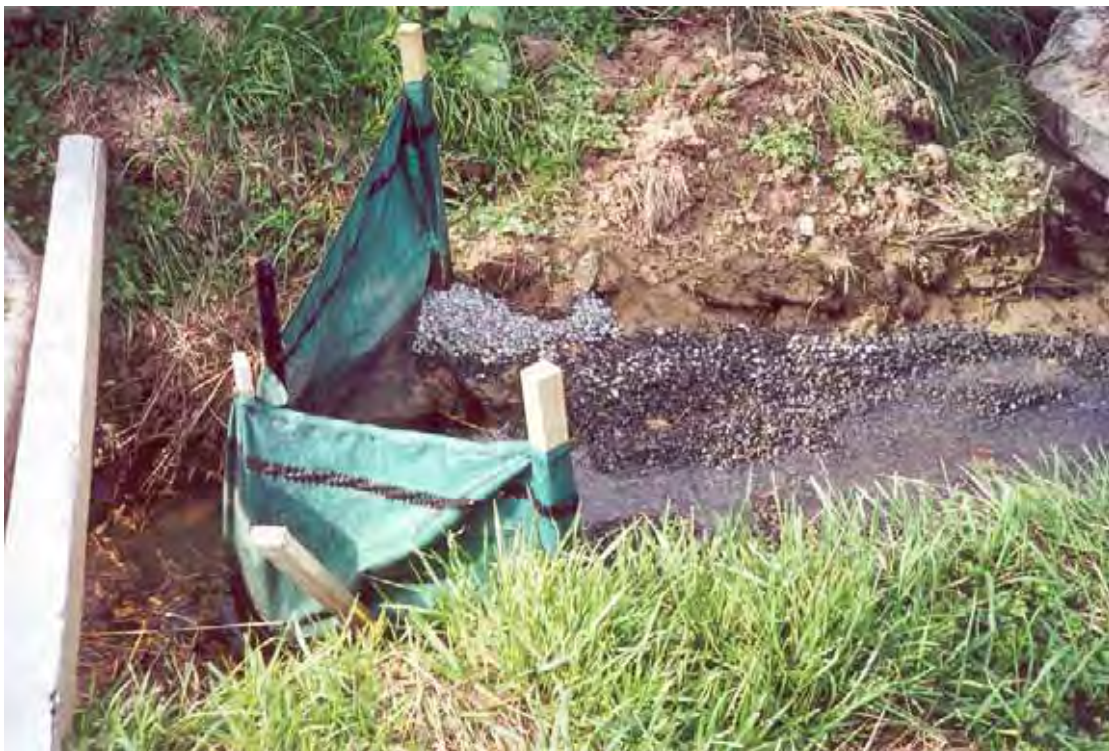
Detail of pump water filter utilising crushed gravel and filter cloth.
